SCAMMON BAY HEALTH CLINIC

Alaska Rural Primary Care Facility Code and Condition Survey

Final
July 23, 2001

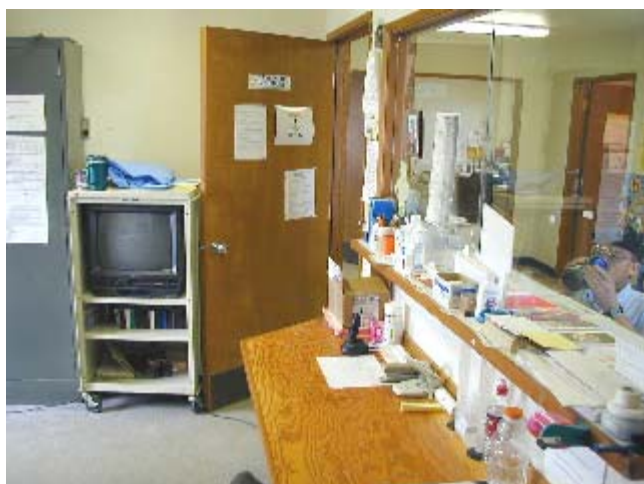
Office to waiting beyond

- e. Office / Administration / Records – This room has a two desks, copier, fax, a single patient chair, and considerable storage. There is a sliding glass window to the waiting room that does not provide adequate privacy for patient interviews and phone calls. This room is not large enough for an office and when a patient is also in the room it is very tight. The electrical service is totally inadequate for this room and the facility.

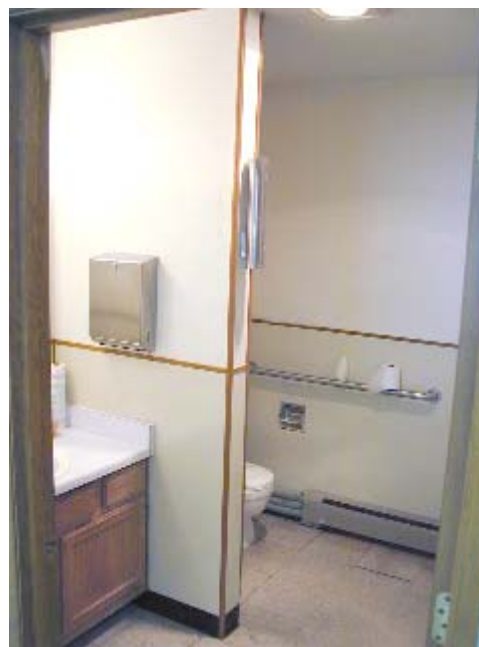
Typical toilet area

- j. HC Toilet Facilities – There are two toilet rooms, one serves patients and the other clinic staff. Neither toilet room meets any of the ADA or UPC requirements. The toilet and sink lacked sufficient clearances and were of incorrect fixture type. There is no vacuum breaker on this sink as required by code. There is no tub. All these areas are very unsanitary due to deteriorating floor system and wall joints from structural shifting.

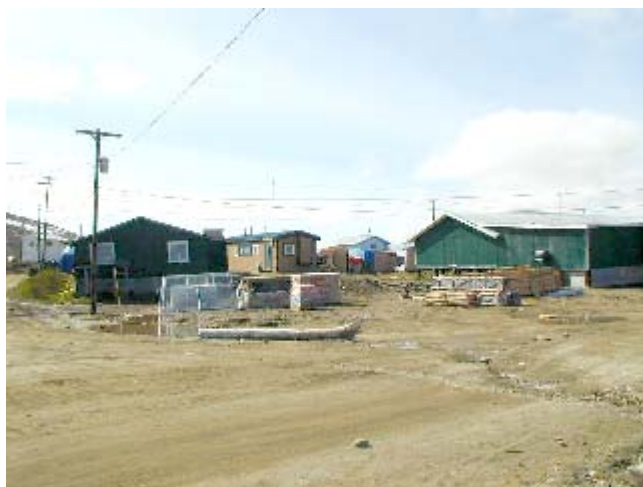
Proposed new site from southeast

The city has provided a new site, adjacent to the new post office, community store, and central to the community other city facilities. It is available immediately for a new clinic. The community has proposed that a new larger 2000 SF Denali Commission Medium Clinic can be constructed on the new site. We have included preliminary site plan for this site and a new 2000 SF clinic. Please note that a 2500 SF clinic could also be accommodated on this site easily.
